1. AGENCY USE ONLY (Leave blank)	2. REPORT DATE 1996	3. REPORT TYPE AND DATES COVERED Final Report		
4. TITLE AND SUBTITLE The Old Hospital Complex (5EP1778) Fort Carson, Colorado		5. FUNDING NUMBERS

13. ABSTRACT (Maximum 200 words) <p>The Old Hospital Complex (5EP1778) at Fort Carson, Colorado, consists of 59 buildings. The Complex was built during World War II and is significant due to its association with the history of the United States. The complex is semi-permanent construction, constructed from the Department of the Army's Series 800 plans. This report documents the complex in accordance with Section 1(g) of the Memorandum of Agreement enacted among the Department of the Army, Headquarters Fort Carson, the Colorado State Historic Preservation Office, and the Advisory Council on Historic Preservation.</p> <p style="text-align: center;">DTIC QUALITY INSPECTED 2</p>

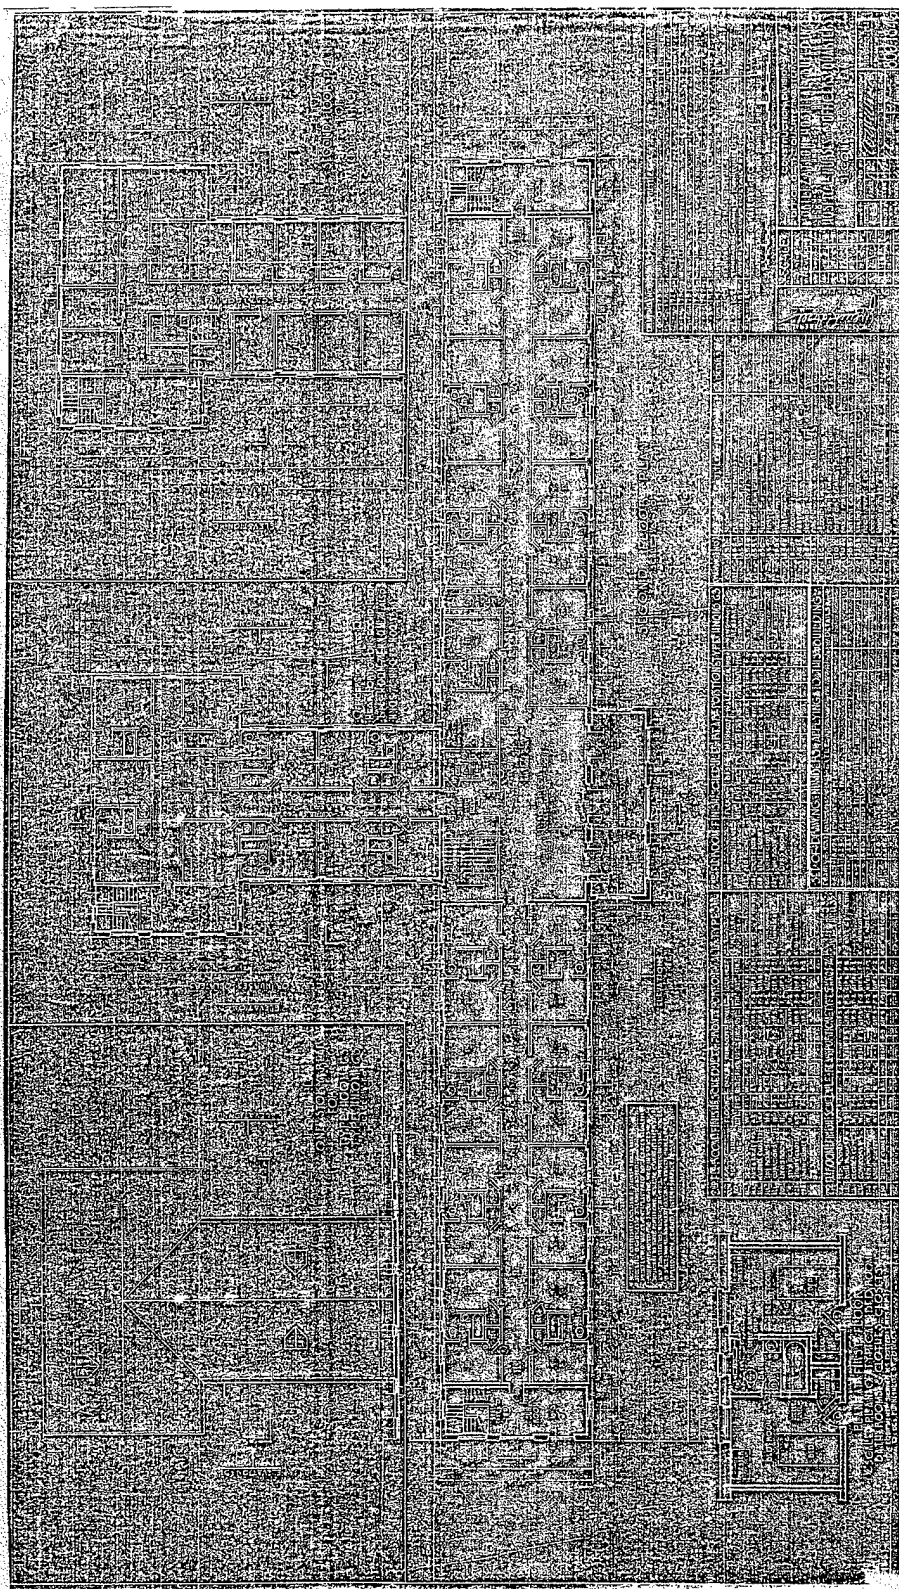
Figure V.133 5EP1778. Second-floor plan for Buildings S6224 and S6228, Hospital Nurses or Officers Quarters, Types HOQM-63, HNQM-63, HNQM-63, HOQM-74, HNQM-74, HNQS-74, HOQ-85, and HNQ-85, 800 Series, Plan 800-1846.

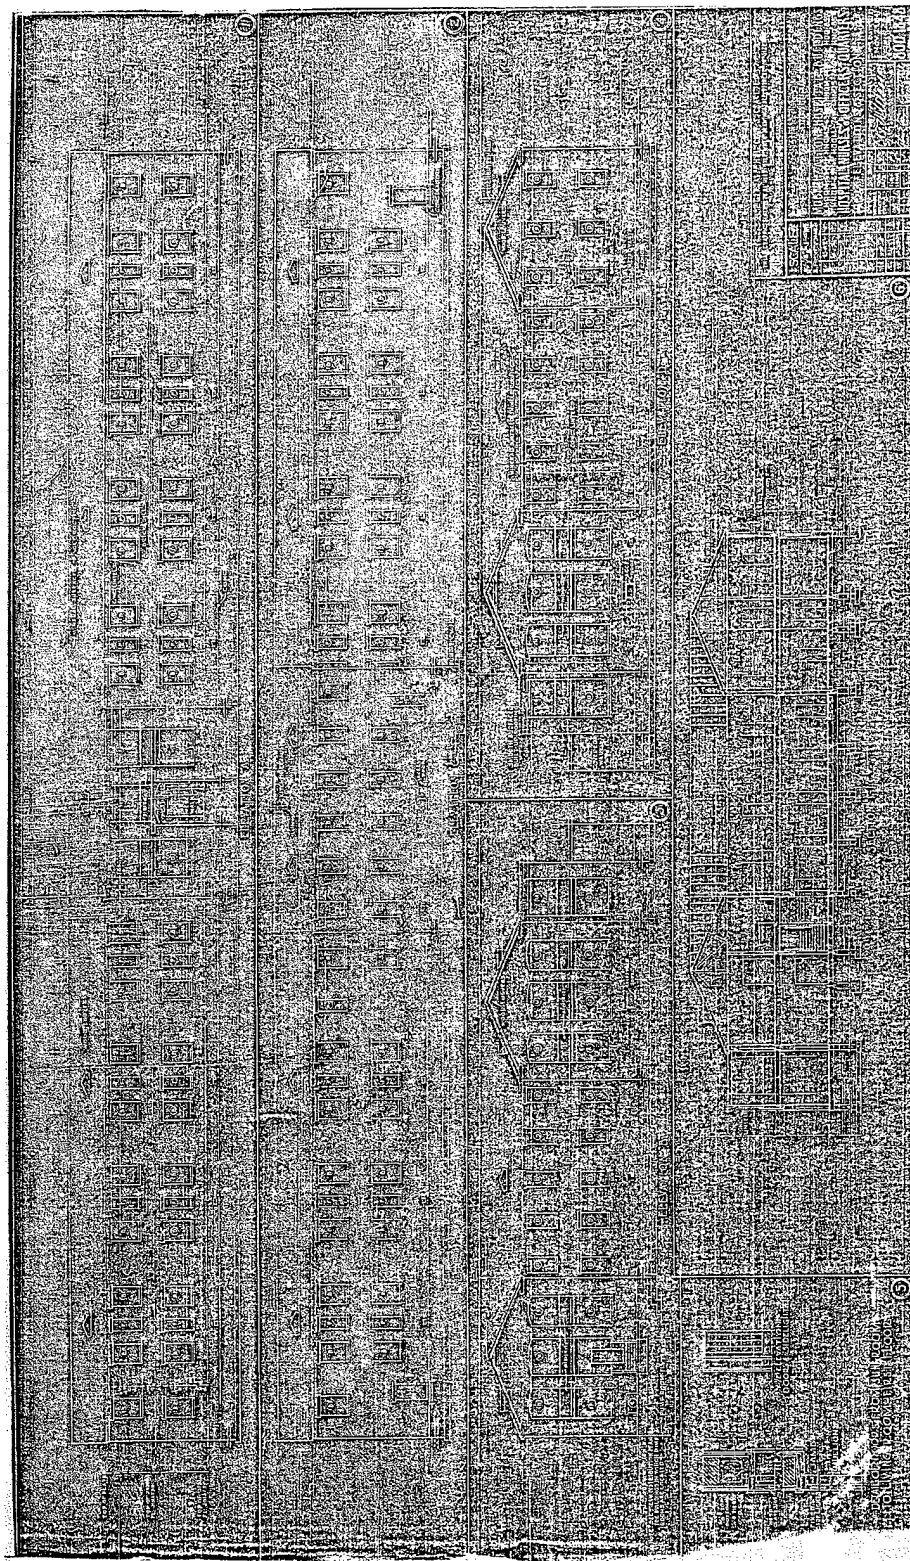
The building's side gable roof is moderately pitched and supported by wood trusses. The original mineral-surfaced shingle roofing has been replaced with three-tab asphalt shingles. Five louvered triangular eyebrow dormer vents are symmetrically arranged on the north and south roof slopes of the upper crossbar. Two additional dormers sit on the south-facing roof slope of the lower crossbar, and the upright portion of the building joining the two crossbars has one dormer on each slope. Additional louvered vents sit under both gable peaks. The boxed eave overhangs 6" on the north and south sides. The gable ends have subtle cornice returns at the eave line. The cornice consists of a single 1" x 12" board topped with a strip of crown molding.

Figure V.134 SEP1778. Elevations and section for Buildings S6224 and S6228, Hospital Nurses or Officers Quarters, 800 Series, Types HOQM-63, HNQM-63, HNQMS-63, HOQM-74, HNQM-74, HNQS-74, HOQ-85, and HNQ-85, Plan 800-1848.

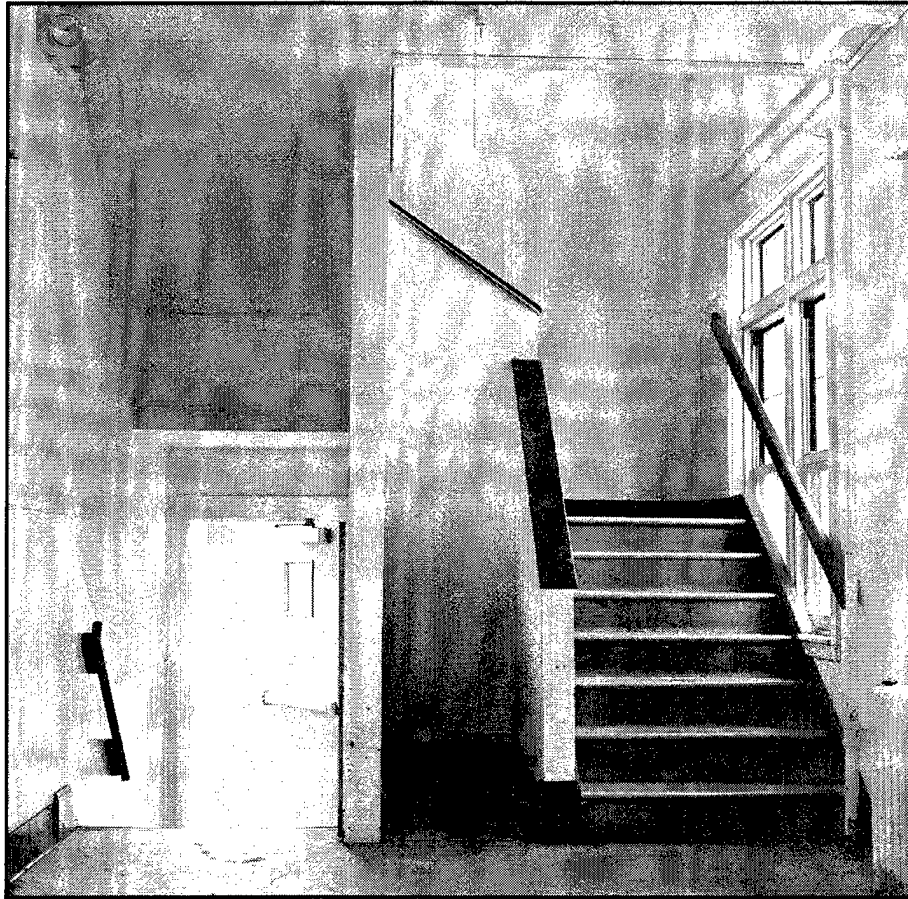
Building S6228's structural system consists of load-bearing cinder block exterior walls, and piers. The end stairwells are fully enclosed by cinder block walls. The floor system is wood-joist construction. The joists bear on interior, built-up longitudinal beams. The second-floor beams transfer loads to the foundation piers via solid wood pillars.

Figure V.140 5EP1778. Building S6228, Hospital Nurses or Officers Quarters, 800 Series, Types HOQM-63, HNQM-63, HNQMS-63, HOQM-74, HNQM-74, HNQS-74, HOQ-85, and HNQ-85. Interior detail of wood column and joist. Roll 3A, Exposure 6.

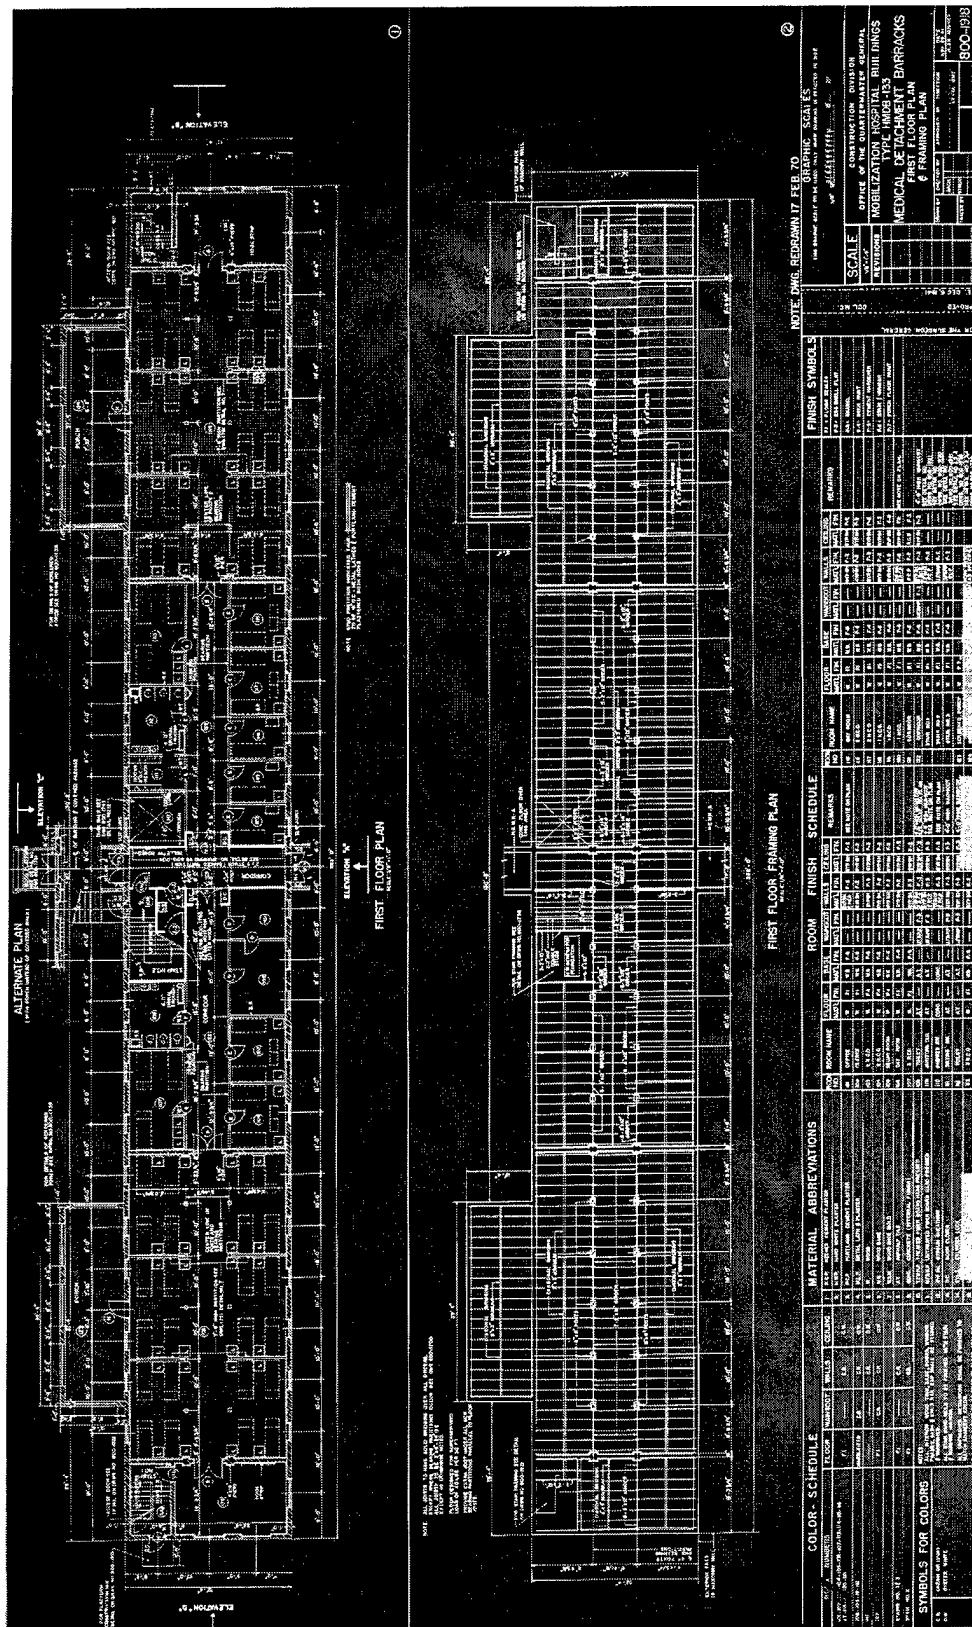
Figure V.141 SEP1778. First-floor plan and framing plan for Building S6281, Medical Detachment Barracks, 800 Series, Type HMDB-133, Plan 800-1918.

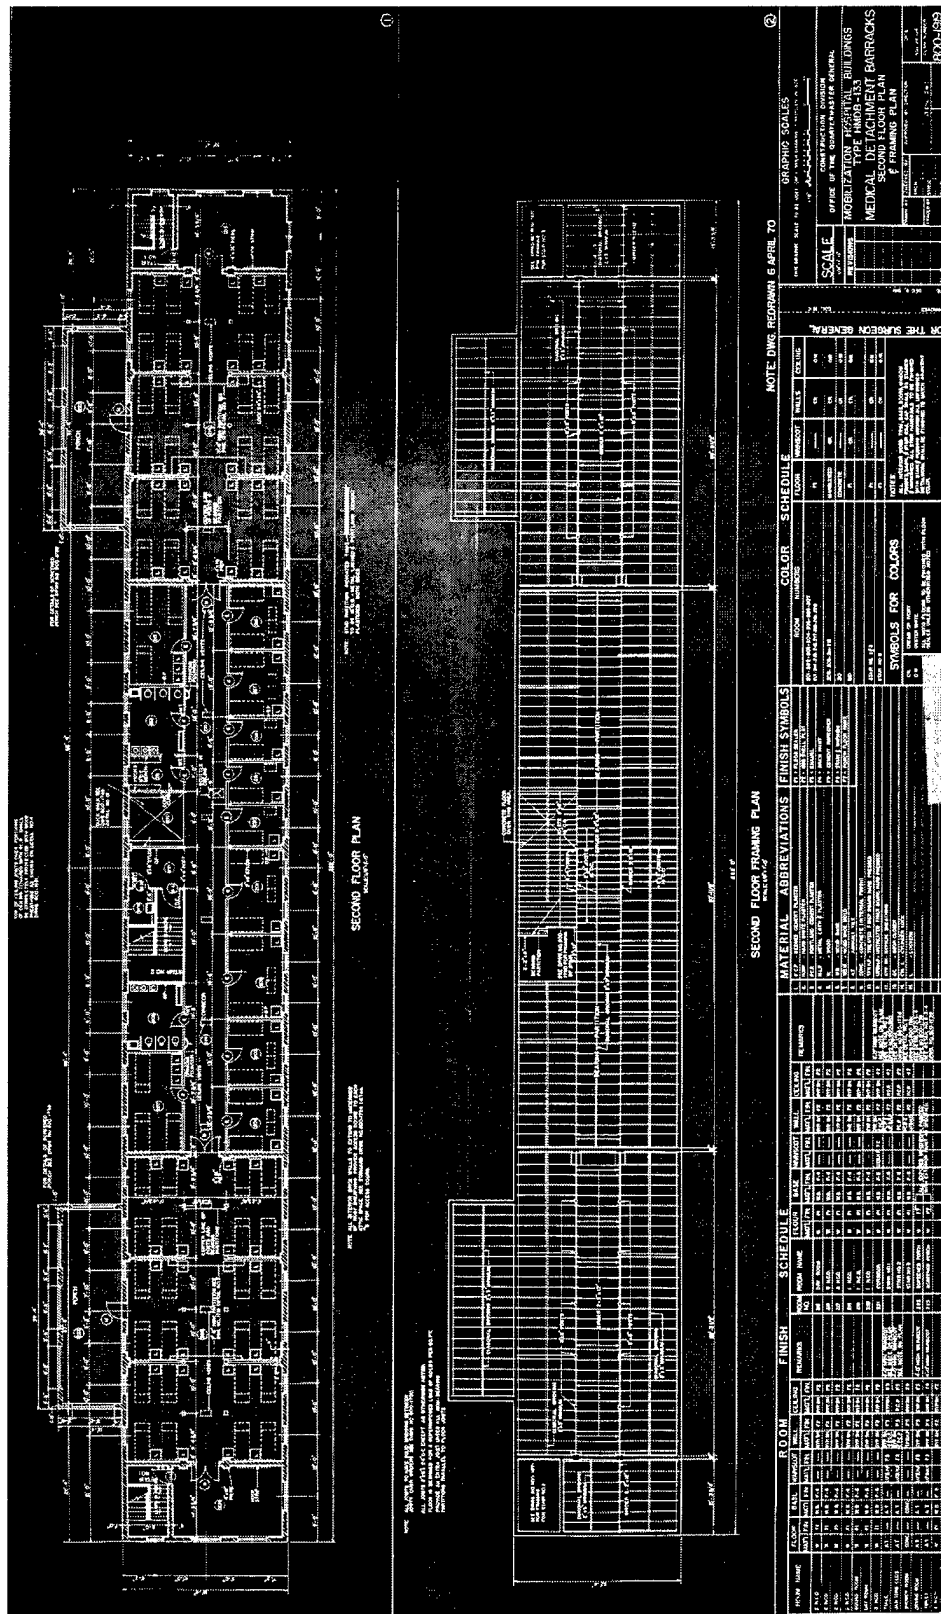
Figure V.142 5EP1778. Second-floor plan and framing plan for Building S6281, Medical Detachment Barracks, 800 Series, Type HMDB-133, Plan 800-1919.

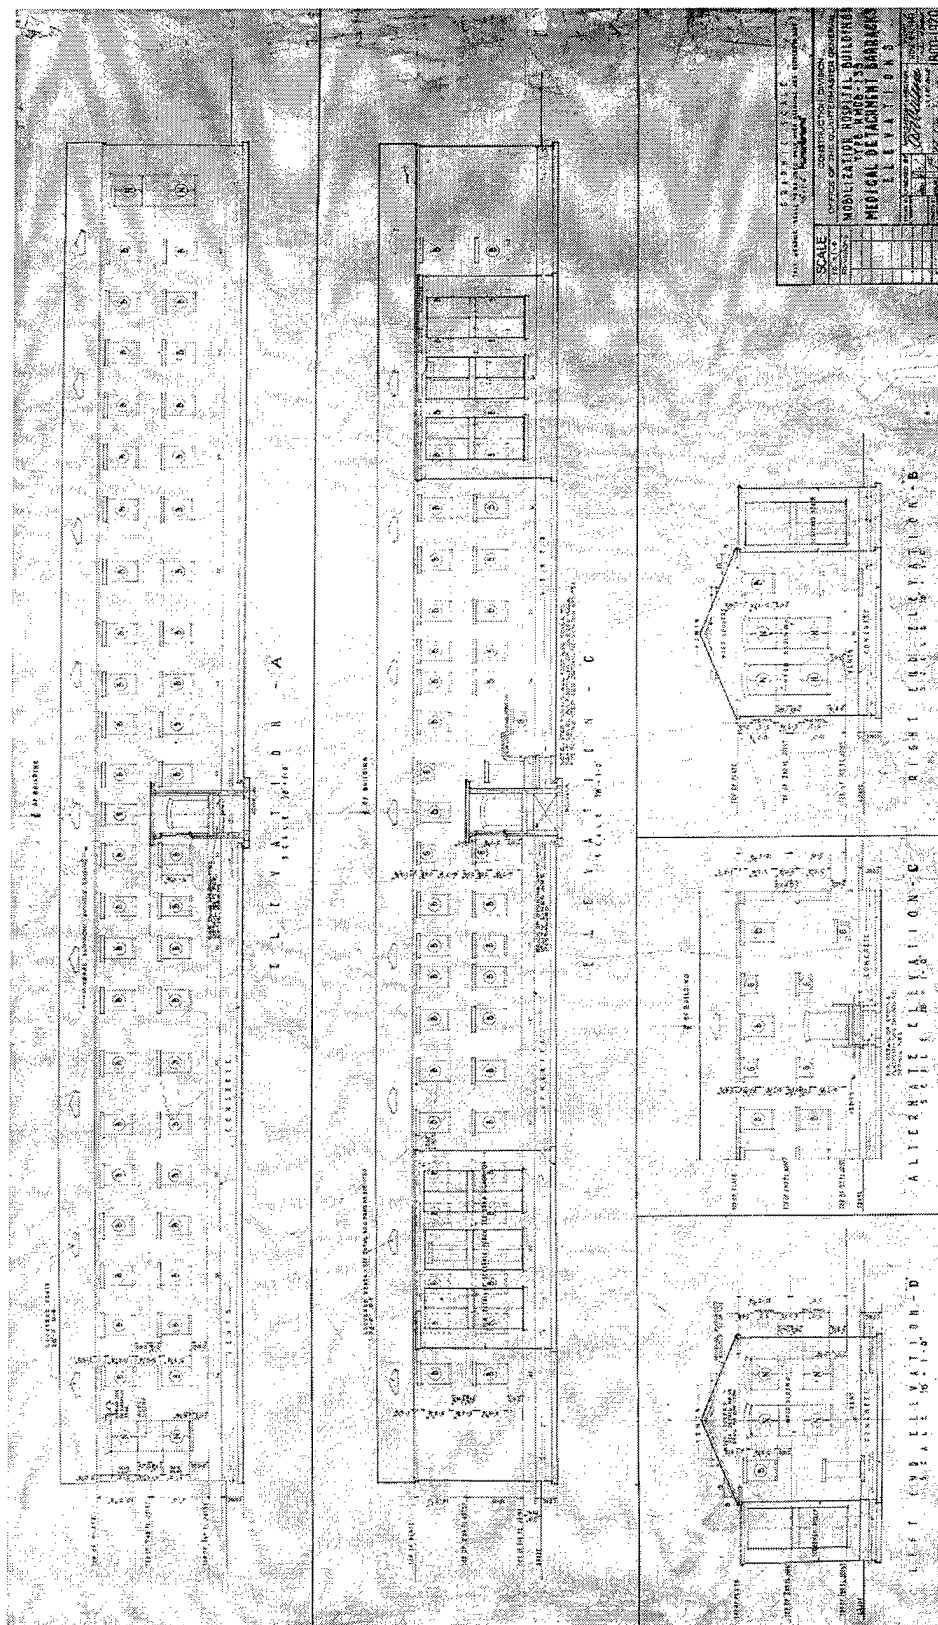
Figure V.143 5EPI778. Elevations for Building S6281, Medical Detachment Barracks, 800 Series, Type HMDB-133, Plan 800-1920.

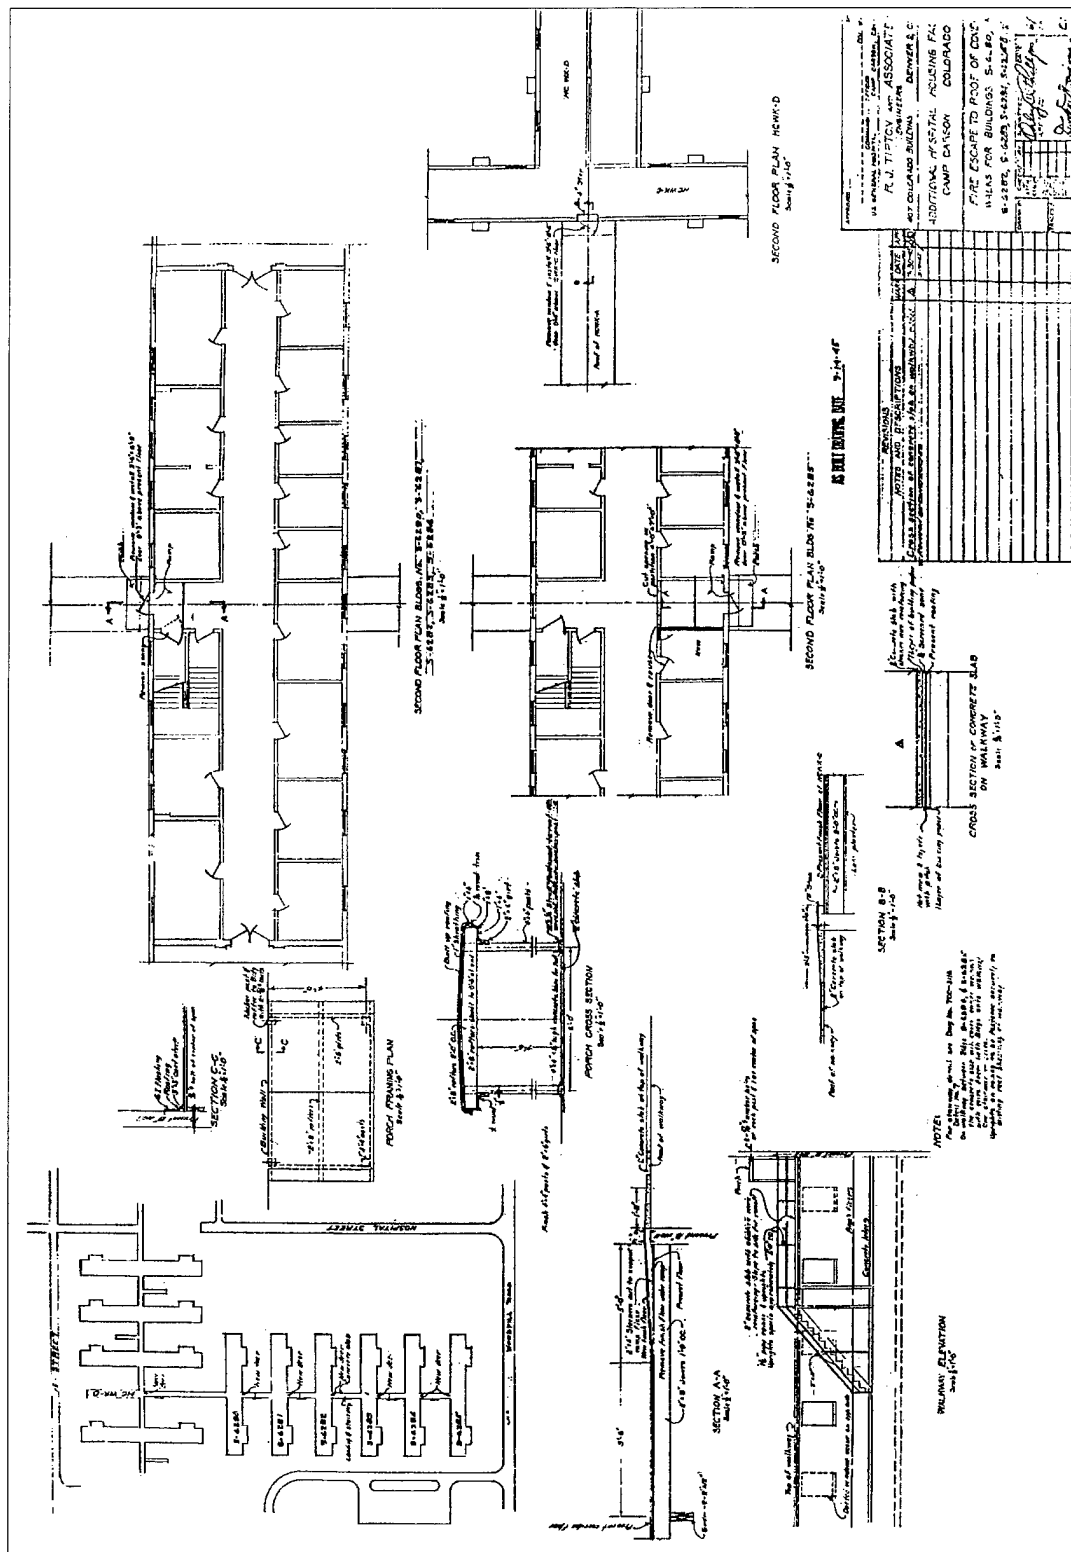
Figure V.144 SEP1778. Fire escape plan for Building S6281, Medical Detachment Barracks, CCH Series, Sheet (illegible).

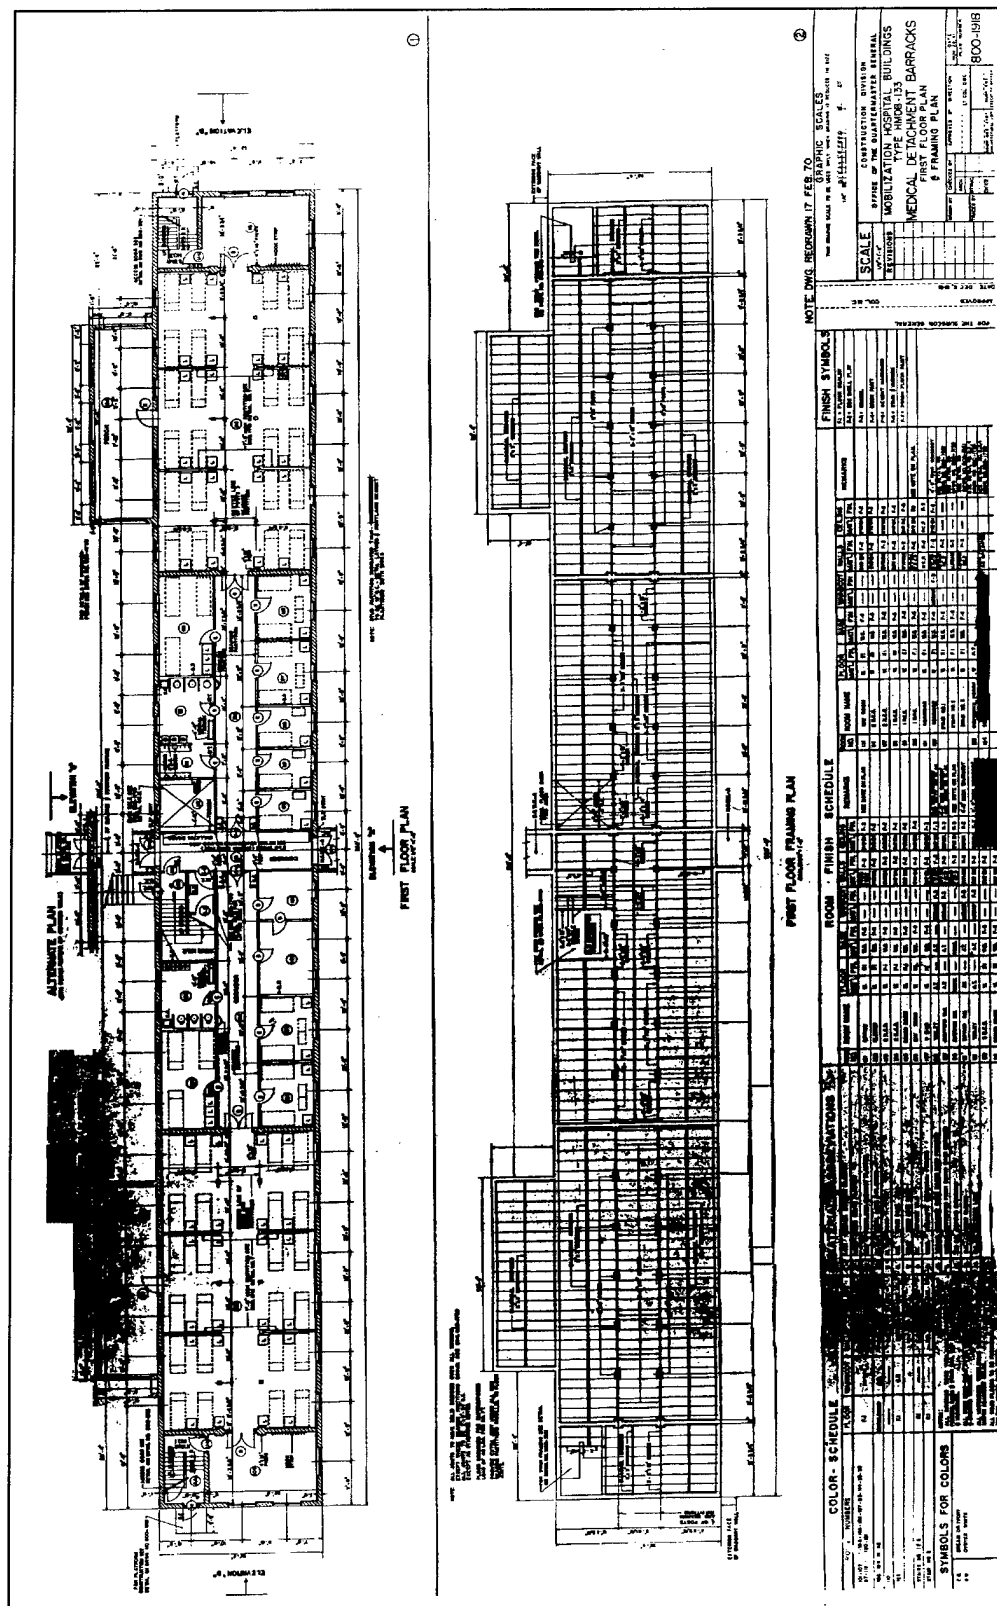
Figure V.145 5EP1778. First-floor plan for Building S6281, Medical Detachment Barracks, BUD Series.

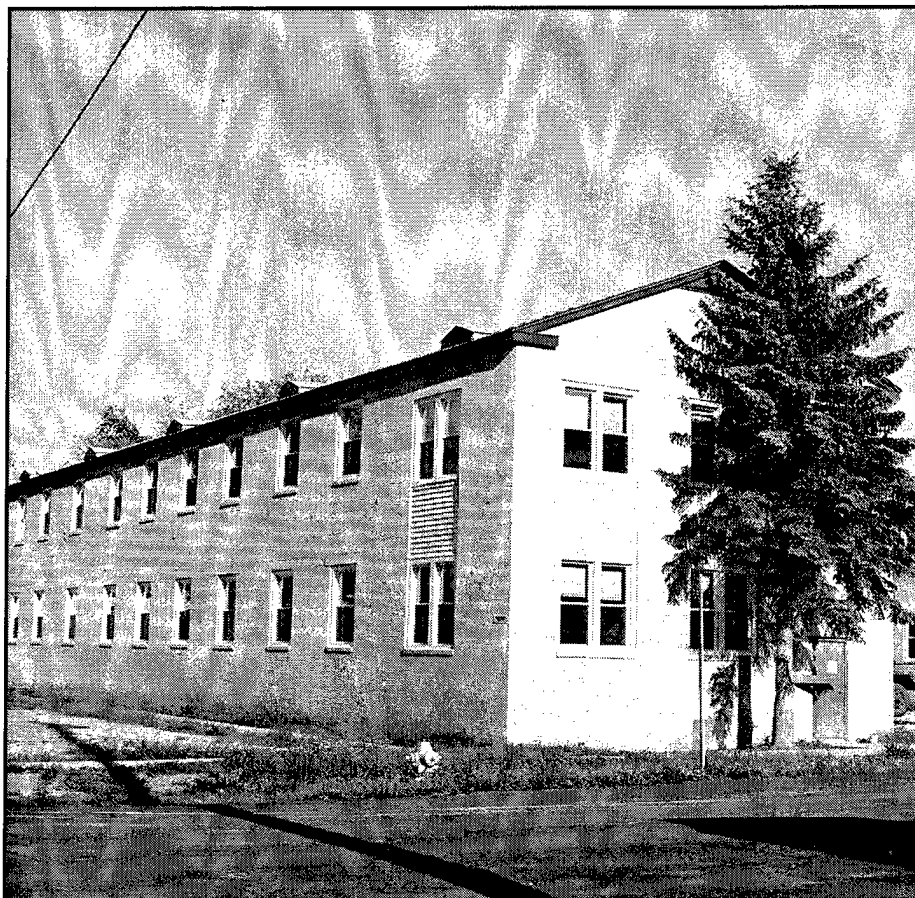
Figure V.147 5EP1778. Building S6281, Medical Detachment Barracks, 800 Series, Type HMDB-133. Three-quarter view of north and west faces of west wing. Roll 11D2, Exposure 8.

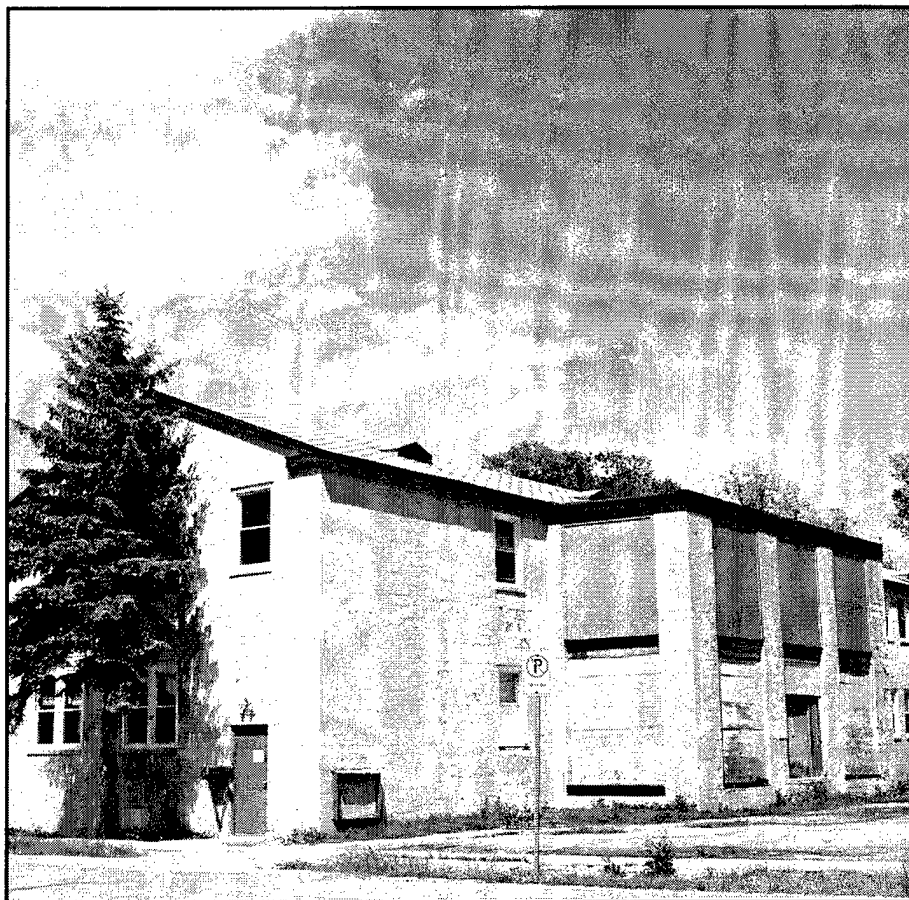
Figure V.148 5EP1778. Building S6281, Medical Detachment Barracks, 800 Series, Type HMDB-133. Three-quarter view of west and south faces of west wing. Roll 6D, Exposure 5.

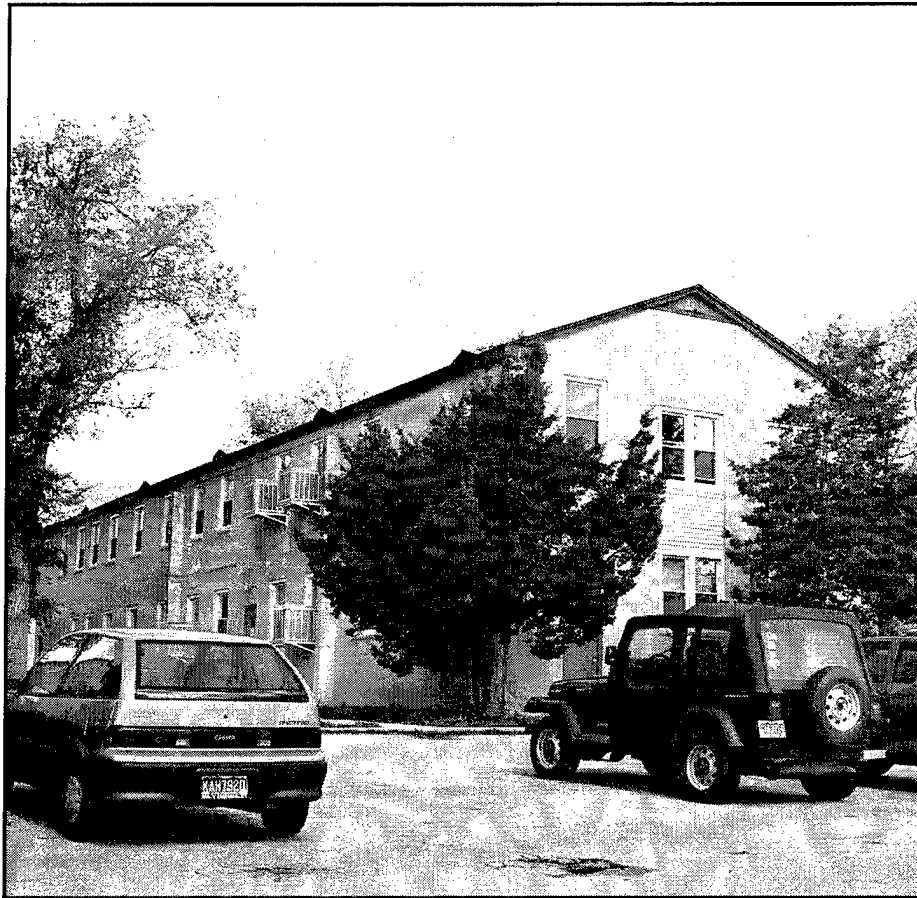
Figure V.149 5EP1778. Building S6281, Medical Detachment Barracks, 800 Series, Type HMDB-133. Three-quarter view of east and south faces of east wing. Roll 2D, Exposure 3.

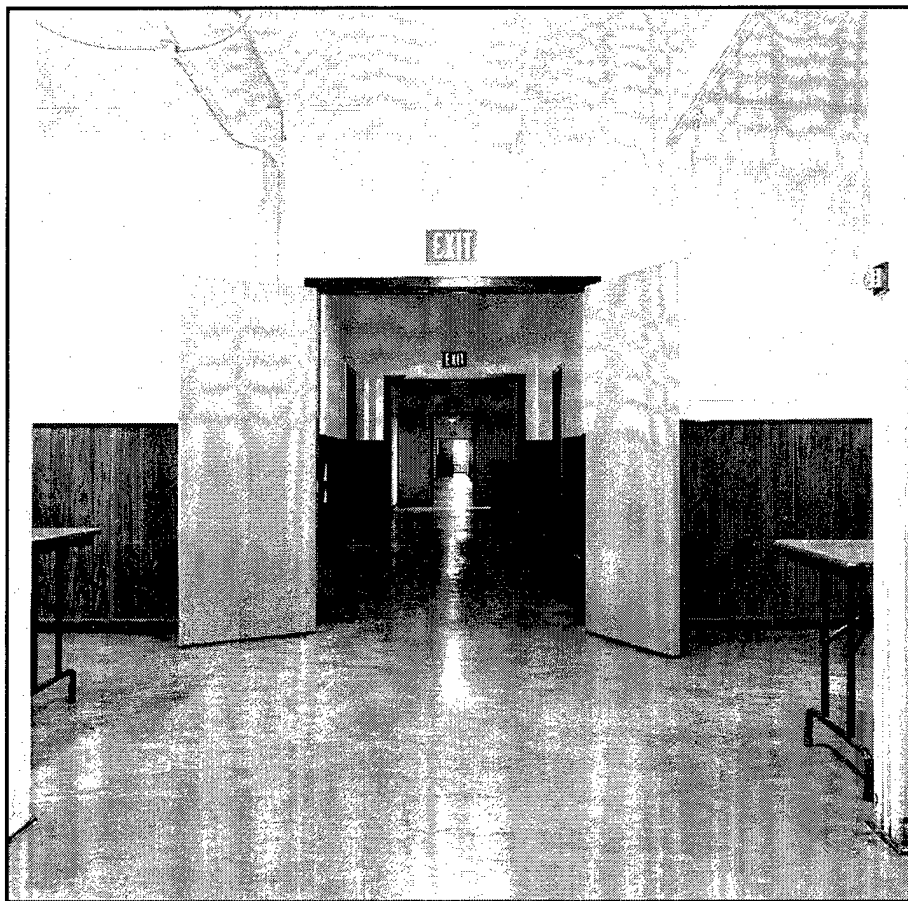
Figure V.150 5EP1778. Building S6281, Medical Detachment Barracks, 800 Series, Type HMDB-133. Interior shot of second floor from west end. Roll 9D2, Exposure 2.

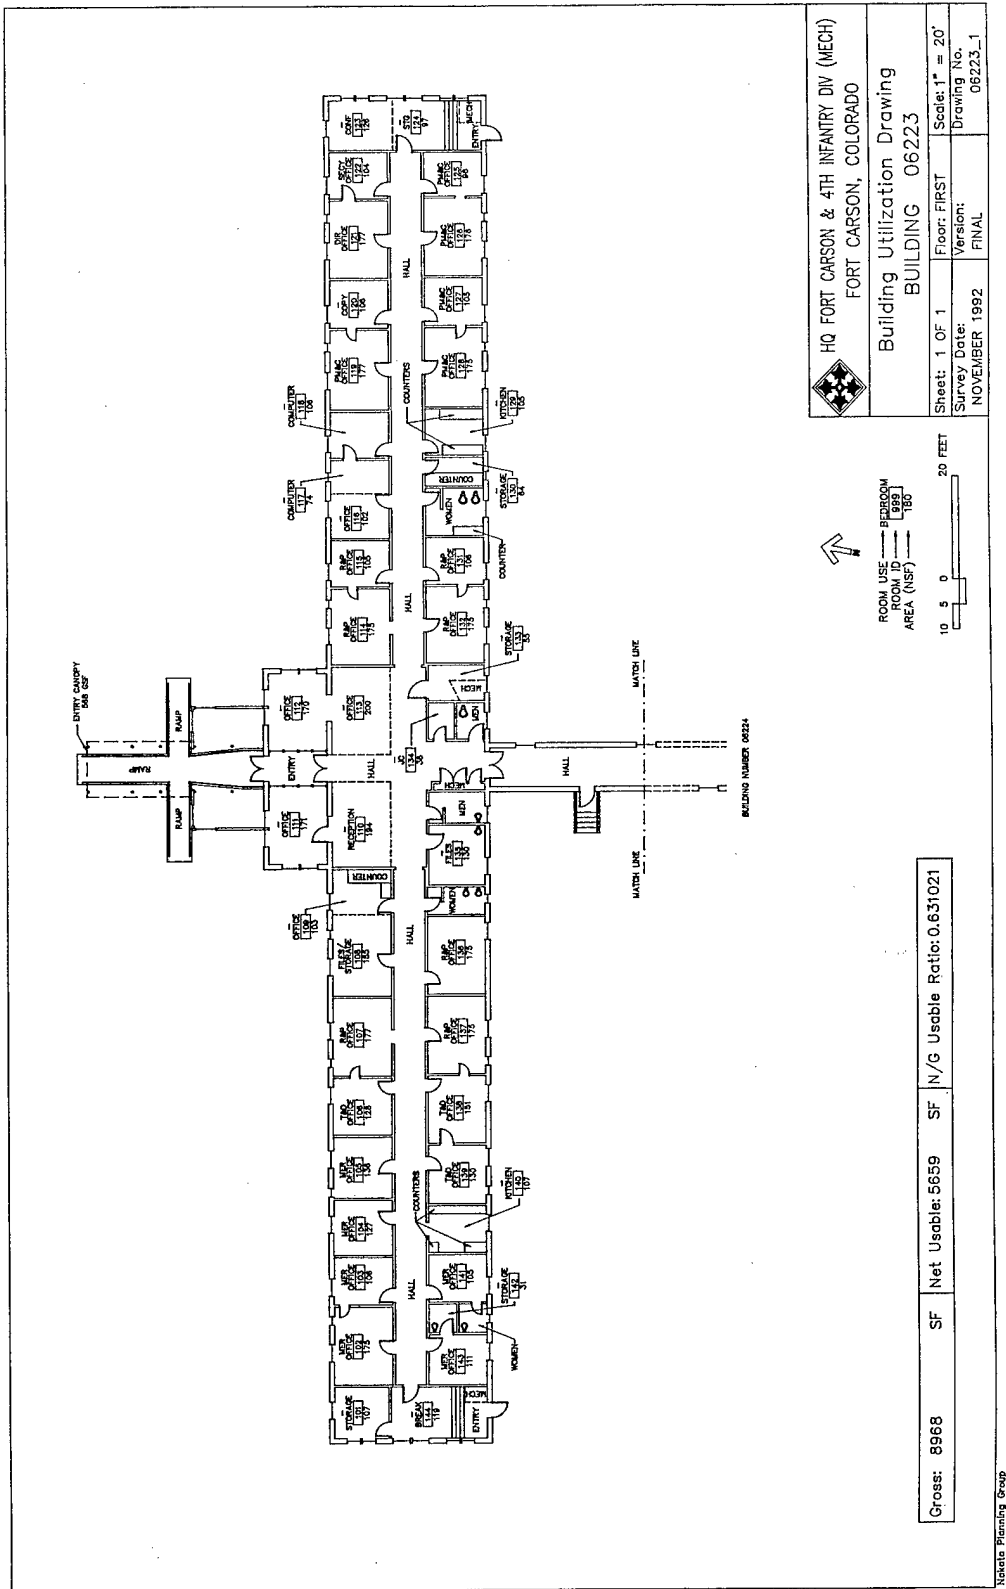
Figure V.152 5EP1778. First-floor plan for Building S6223, Nurses or Officers Quarters, BUD Series.

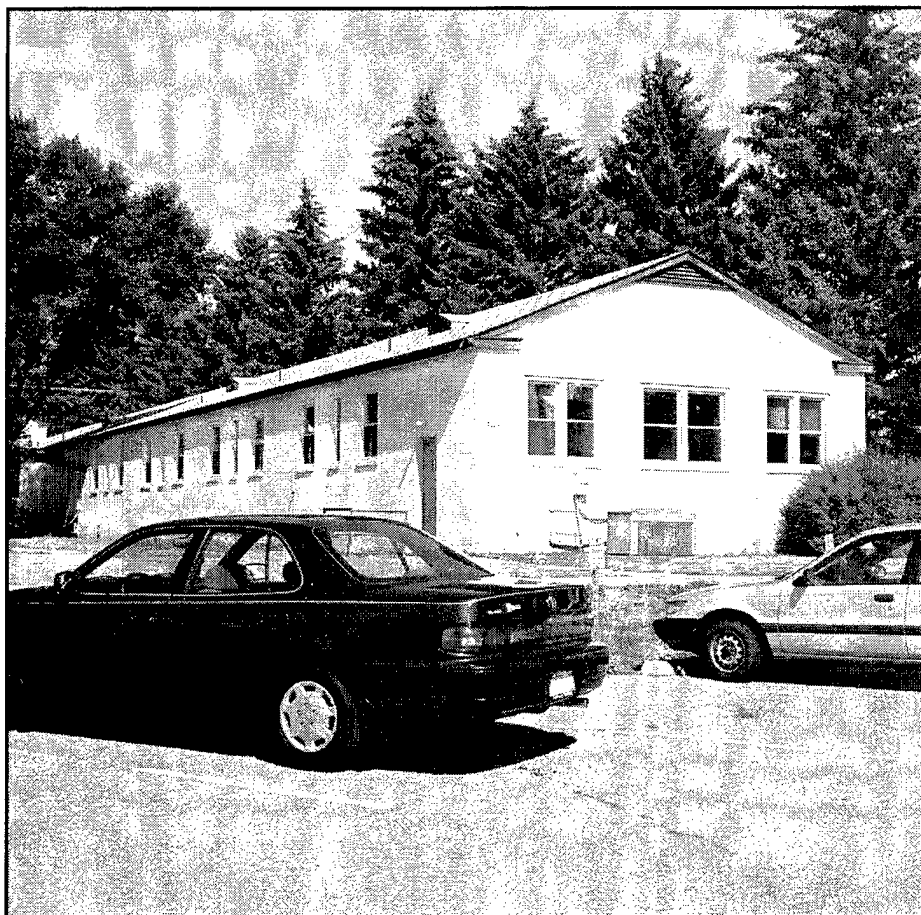
Figure V.156 5EP1778. Building S6223, Nurses or Officers Quarters, 800 Series, Type HNQ-31 or HOQ-31. Three-quarter view of south and east facades. Roll 2A, Exposure 7.

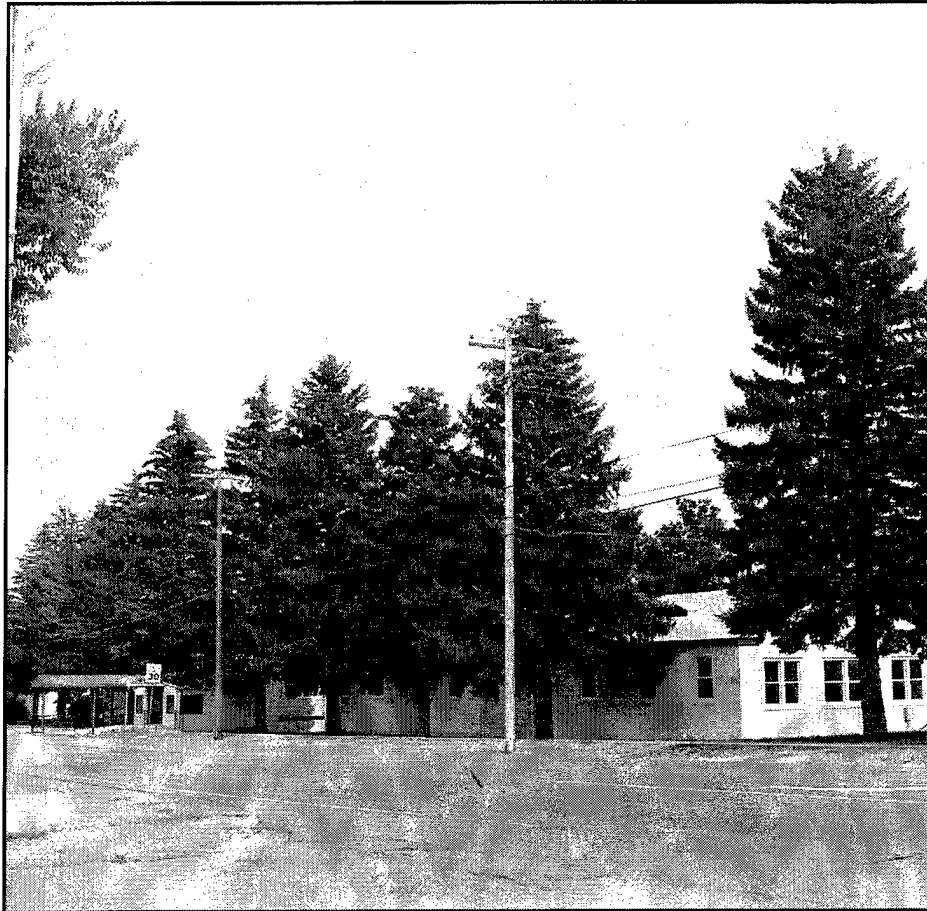
Figure V.157 5EP1778. Building S6223, Nurses or Officers Quarters, 800 Series, Type HNQ-31 or HOQ-31. Three-quarter view of north and west facades. Roll 10A, Exposure 10.

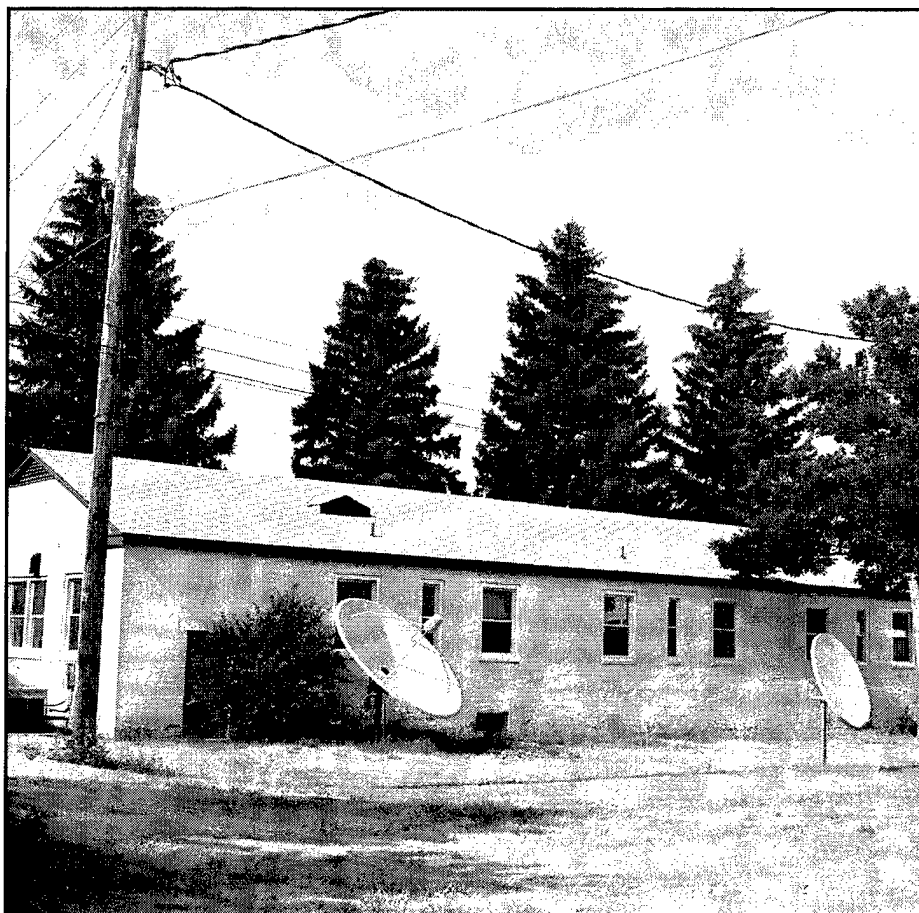
Figure V.158 5EP1778. Building S6223, Nurses or Officers Quarters, 800 Series, Type HNQ-31 or HOQ-31. Three-quarter view of south and west facades. Roll 10A, Exposure 8.

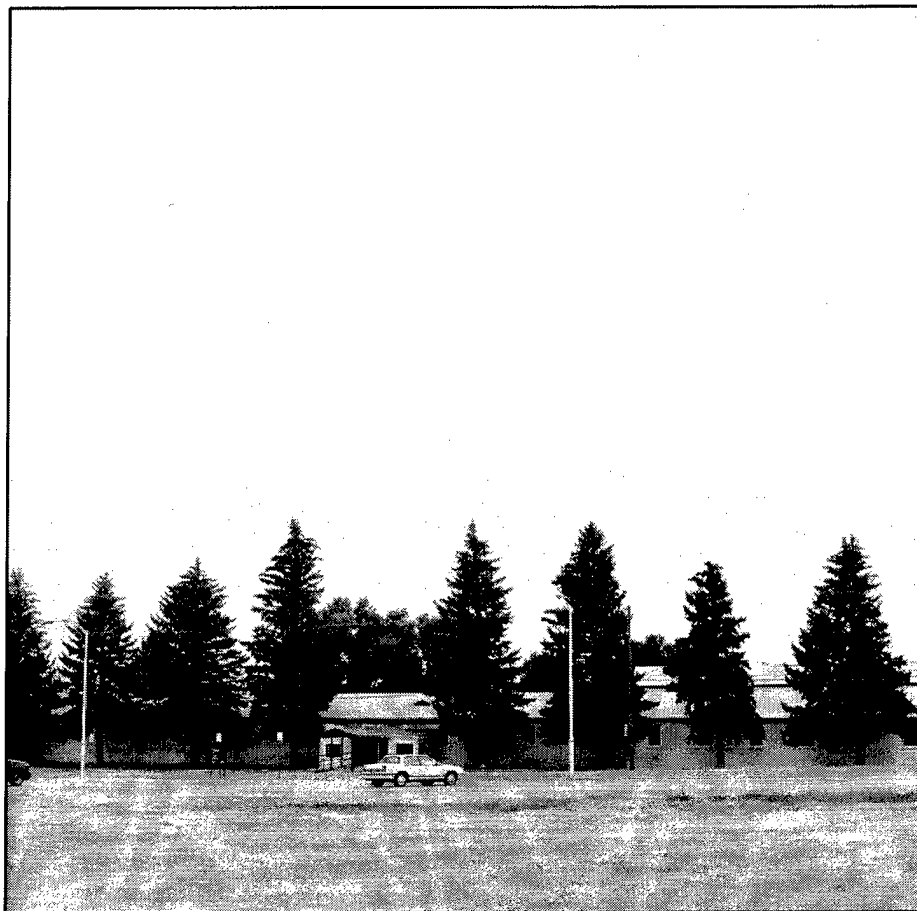
Figure V.159 5EP1778. Building S6223, Nurses or Officers Quarters, 800 Series, Type HNQ-31 or HOQ-31. North elevation. Roll 11A, Exposure 1.

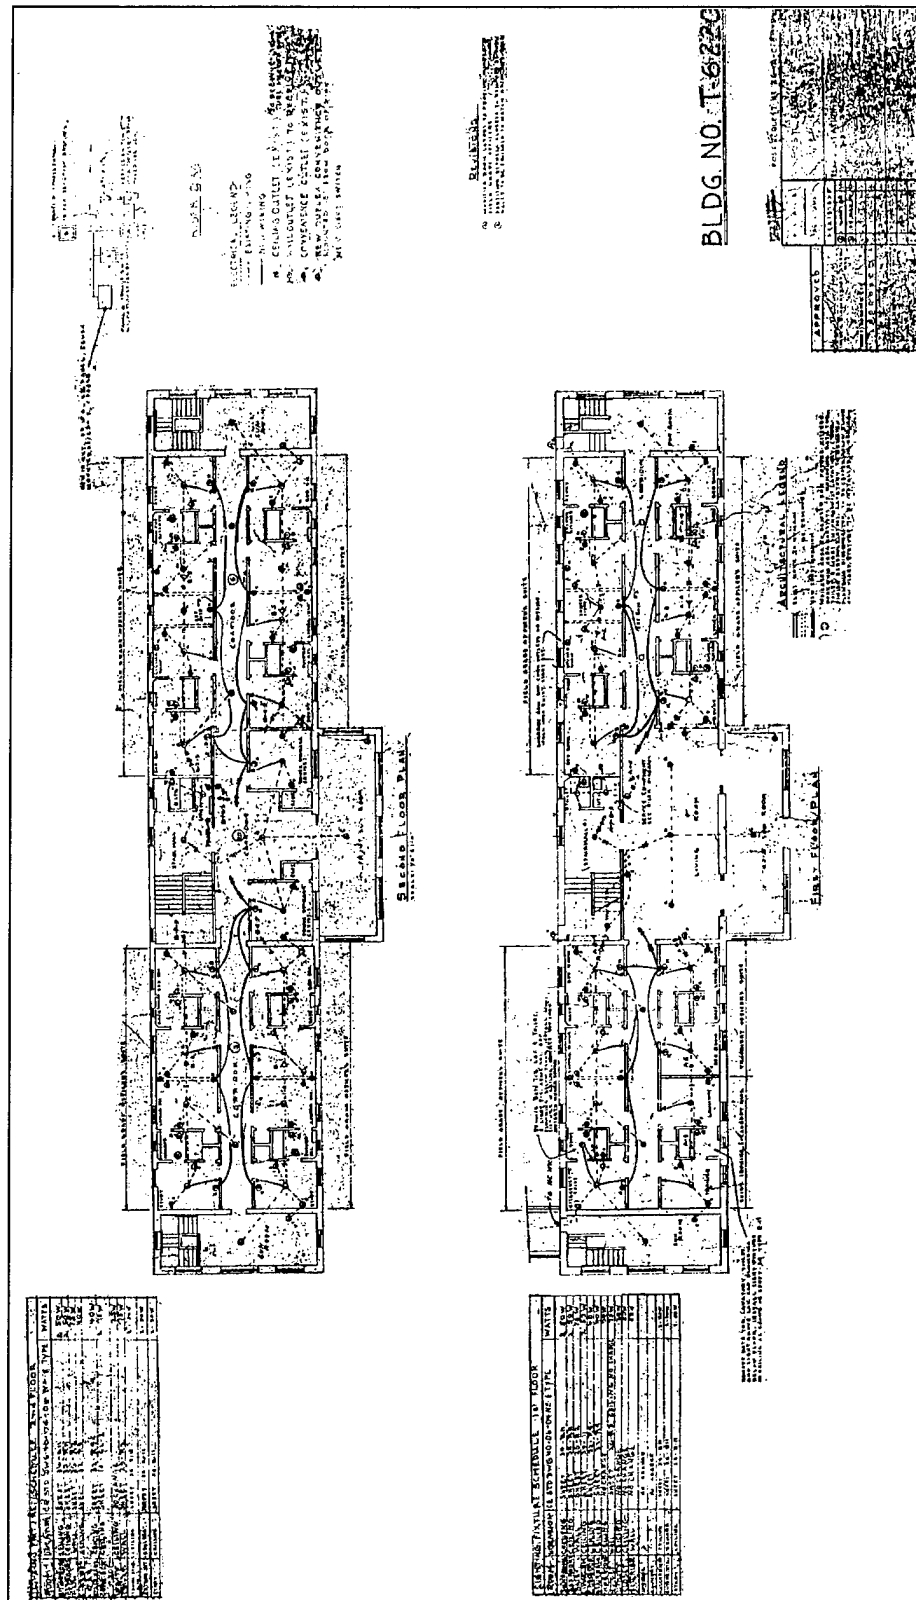
Figure V.161 5EPI778. Renovation plan for Building S6220, Hospital Nurses Quarters, CSA-362, PEA Series Plan (illegible).
